ANNUAL REPORT FOR 2011

Ivy Gap Branch Site N Mitigation Site
Madison County
TIP No. R-2518A

Prepared By:
Natural Environment Unit & Roadside Environmental Unit
North Carolina Department of Transportation
December 2011

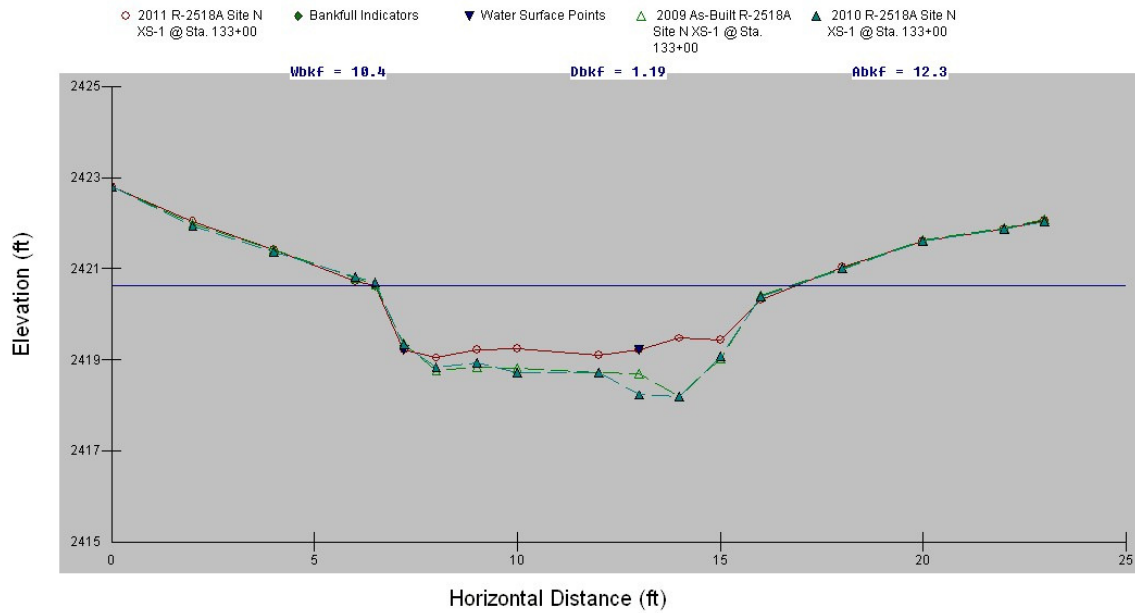
R-2518A Site N XS-1 @ Sta. 133+00

Site N: Cross-Section #1 (Pool) Abbreviated Morphological Summary					
	2010	2011	2012	2013	2014
Bankfull Cross Sectional Area (ft ²)	14.26	12.34			
Maximum Bankfull Depth (ft.)	2.2	1.59			
Bankfull Mean Depth (ft.)	1.53	1.19			
Bankfull Width (ft.)	9.34	10.37

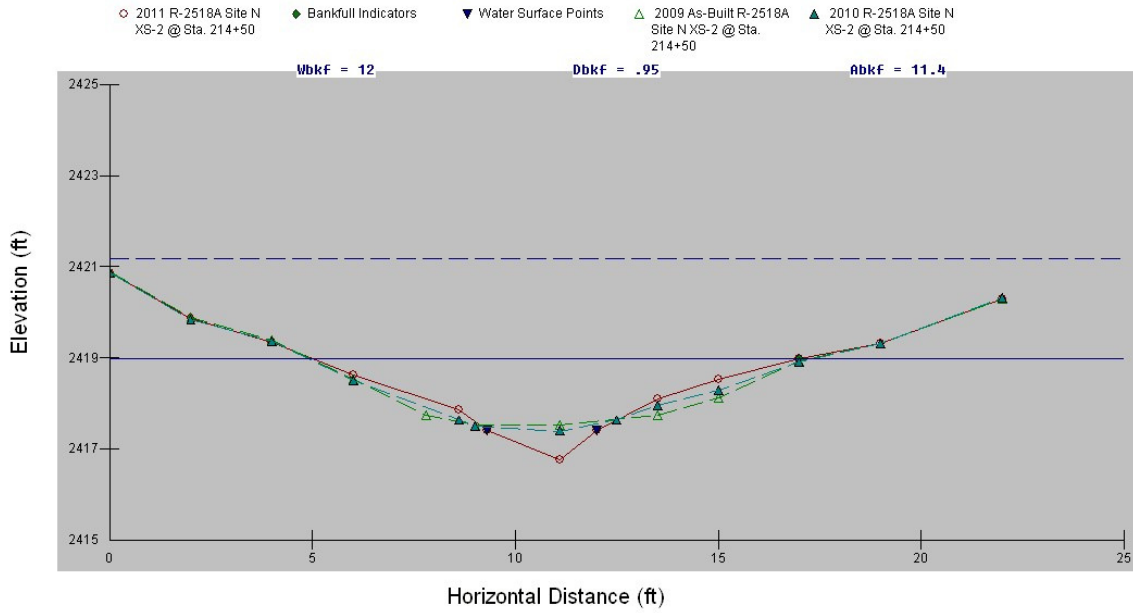
R-2518A Site N XS-2 @ Sta. 214+50

Site N: Cross-Section #2 (Riffle) Abbreviated Morphological Summary					
	2010	2011	2012	2013	2014
Bankfull Cross Sectional Area (ft ²)	17.17	11.37			
Maximum Bankfull Depth (ft.)	1.98	2.21			
Width of the Floodprone Area (ft.)	22	22			
Bankfull Mean Depth (ft.)	1.13	0.95			
Width/Depth Ratio	13.43	12.59			
Entrenchment Ratio	1.45	1.84			
Bankfull Width (ft.)	15.18	11.96

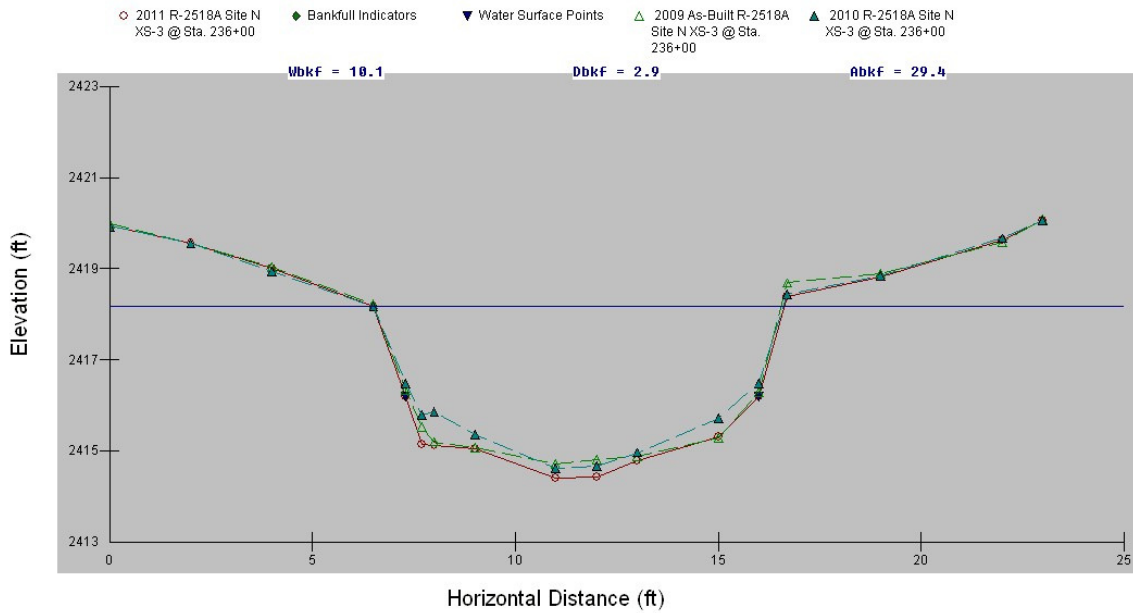
R-2518A Site N XS-3 @ Sta. 236+00

Site N: Cross-Section #3 (Pool) Abbreviated Morphological Summary					
	2010	2011	2012	2013	2014
Bankfull Cross Sectional Area (ft ²)	26.36	29.4			
Maximum Bankfull Depth (ft.)	3.57	3.78			
Bankfull Mean Depth (ft.)	2.61	2.9			
Bankfull Width (ft.)	10.11	10.14

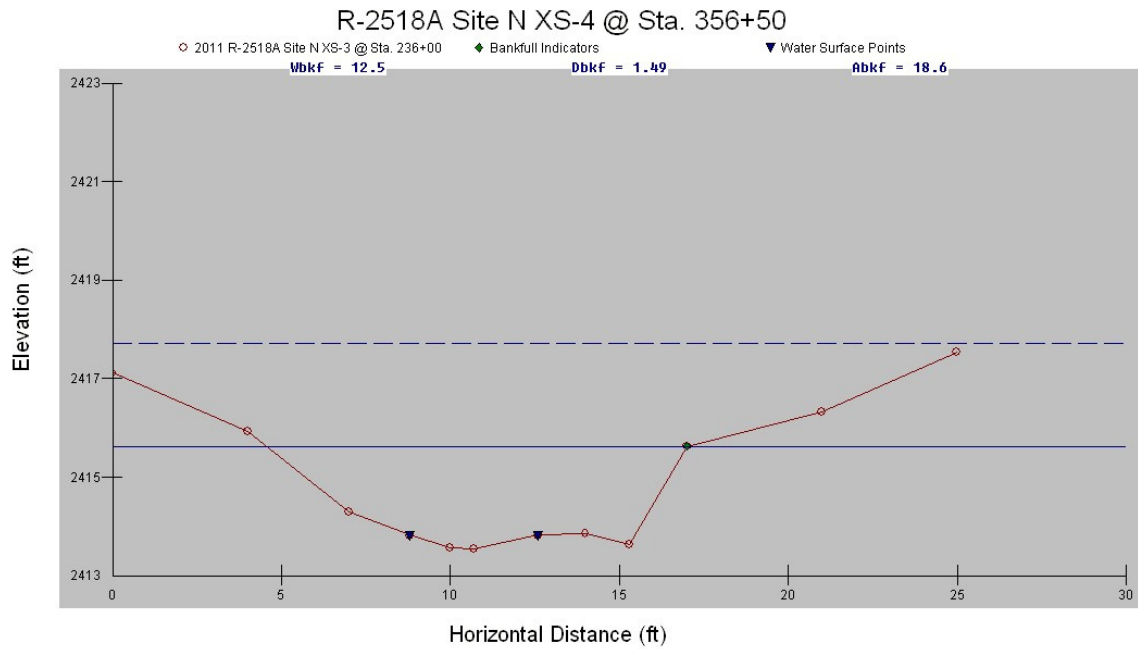
Site N: Cross-Section #4 (Riffle) Abbreviated Morphological Summary				
	2011	2012	2013	2014
Bankfull Cross Sectional Area (ft ²)	18.6			
Maximum Bankfull Depth (ft.)	2.08			
Width of the Floodprone Area (ft.)	25			
Bankfull Mean Depth (ft.)	1.49			
Width/Depth Ratio	8.36			
Entrenchment Ratio	2.01			
Bankfull Width (ft.)	12.45

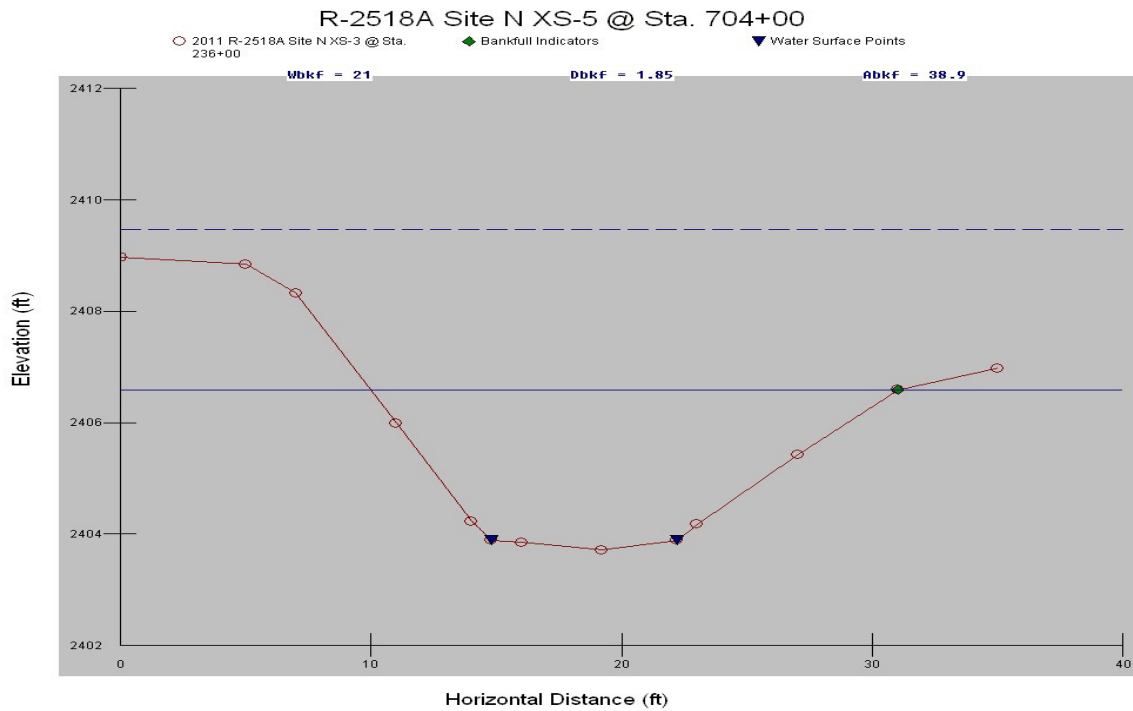
Site N: Cross-Section #5 (Riffle) Abbreviated Morphological Summary				
	2011	2012	2013	2014
Bankfull Cross Sectional Area (ft ²)	38.94			
Maximum Bankfull Depth (ft.)	2.88			
Width of the Floodprone Area (ft.)	35			
Bankfull Mean Depth (ft.)	1.85			
Width/Depth Ratio	11.37			
Entrenchment Ratio	1.66			
Bankfull Width (ft.)	21.03
